**PRELIMINARY ENVIRONMENTAL SITE ASSESSMENT - PHASE I UPDATE
AND SUBSURFACE ASSESSMENT - PHASE II**

Western Portion of Huntington Beach Mall
Former Montgomery Wards Facility
7777 Edinger Avenue
Huntington Beach, California

CE Job No. EP102-2345

September 2005

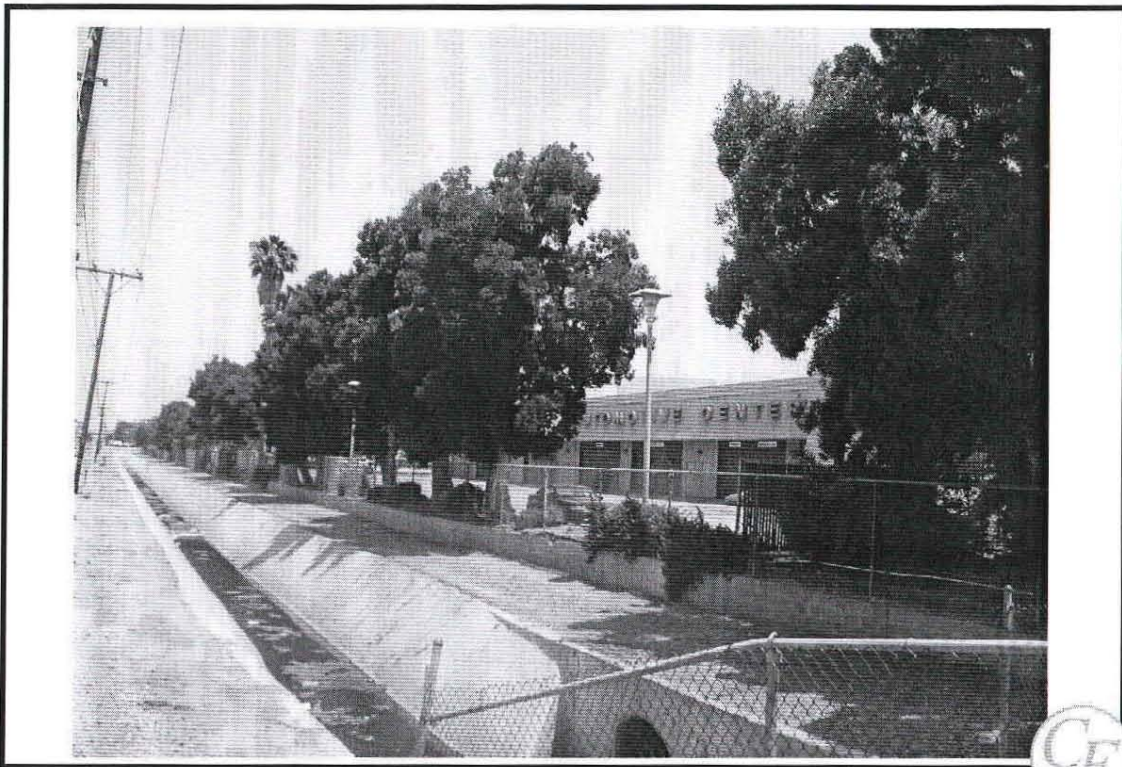
View of channel west of auto center.
7777 Edinger Avenue-Montgomery Wards, Huntington Beach, CA

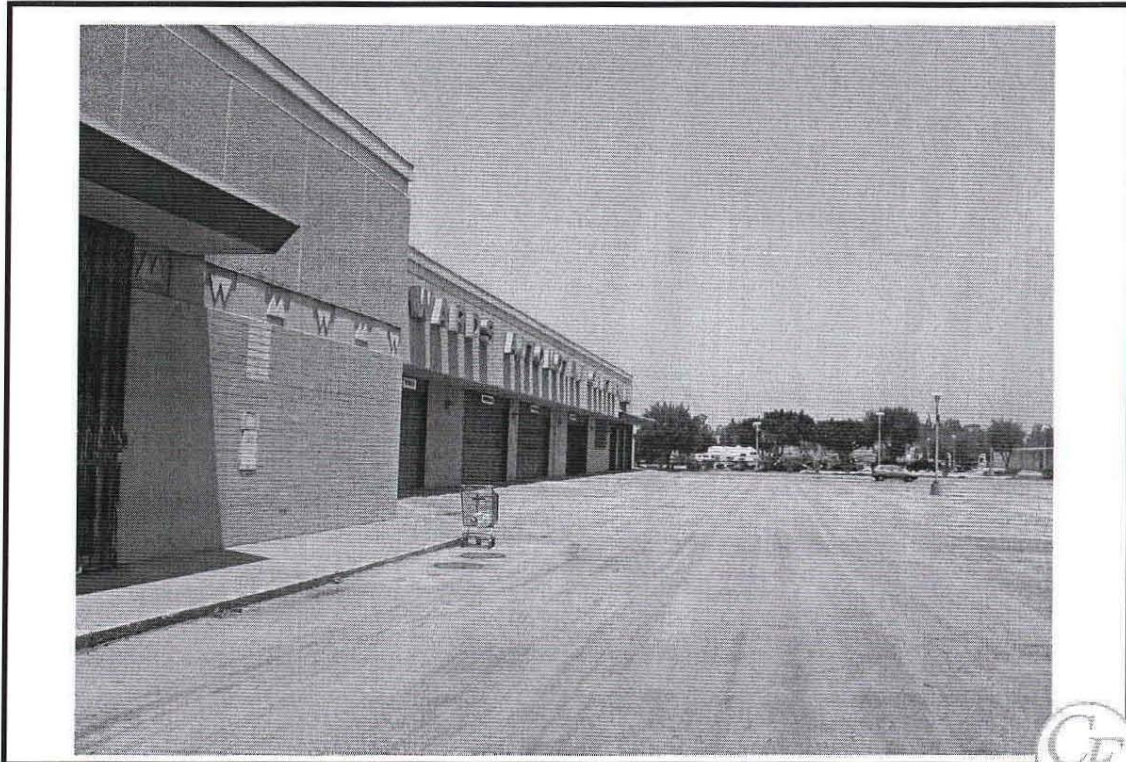
View of eastside of the auto center.
7777 Edinger Avenue-Montgomery Wards, Huntington Beach, CA

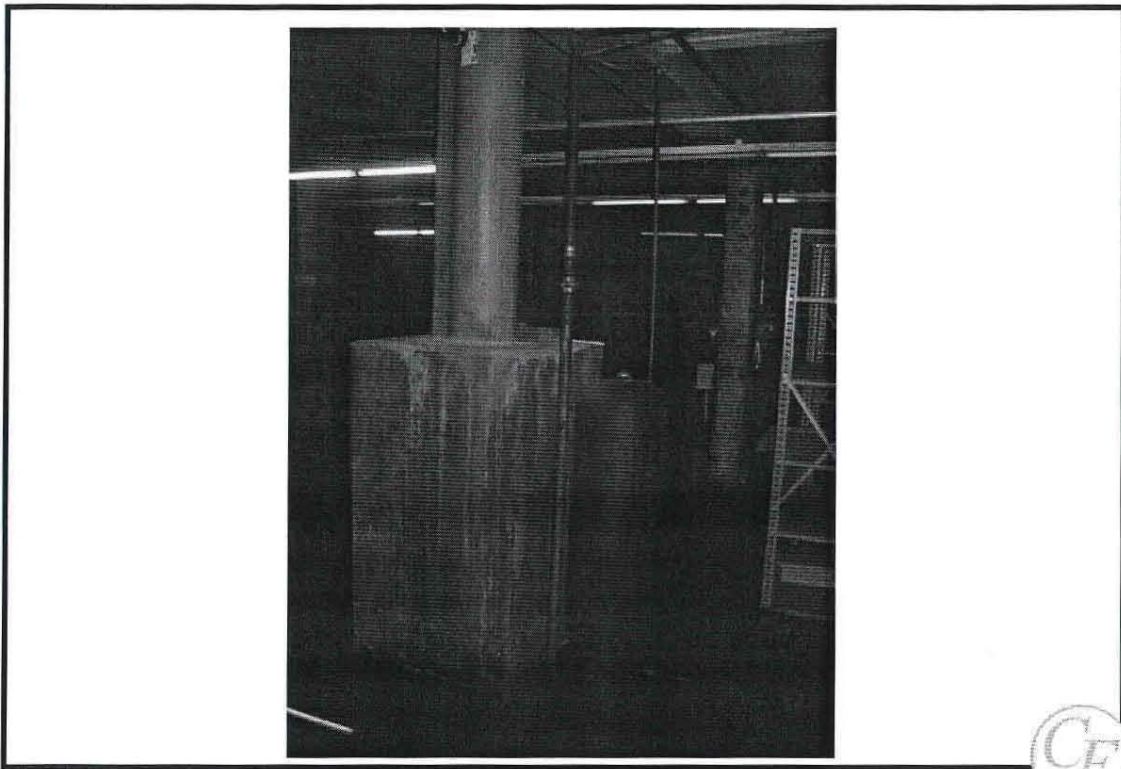
Hydraulic hoists are located within the vacant Montgomery Ward Automotive facility. Some of the hydraulic oil reservoirs are located above ground within the basement of the automotive facility. No leaks of hydraulic oil were observed from the hydraulic oil reservoirs observed within the basement of the structure. Minor oil staining was observed on the concrete surface near two hydraulic hoists.

Hydraulic lift-basement view.
7777 Edinger Avenue-Montgomery Wards, Huntington Beach, CA

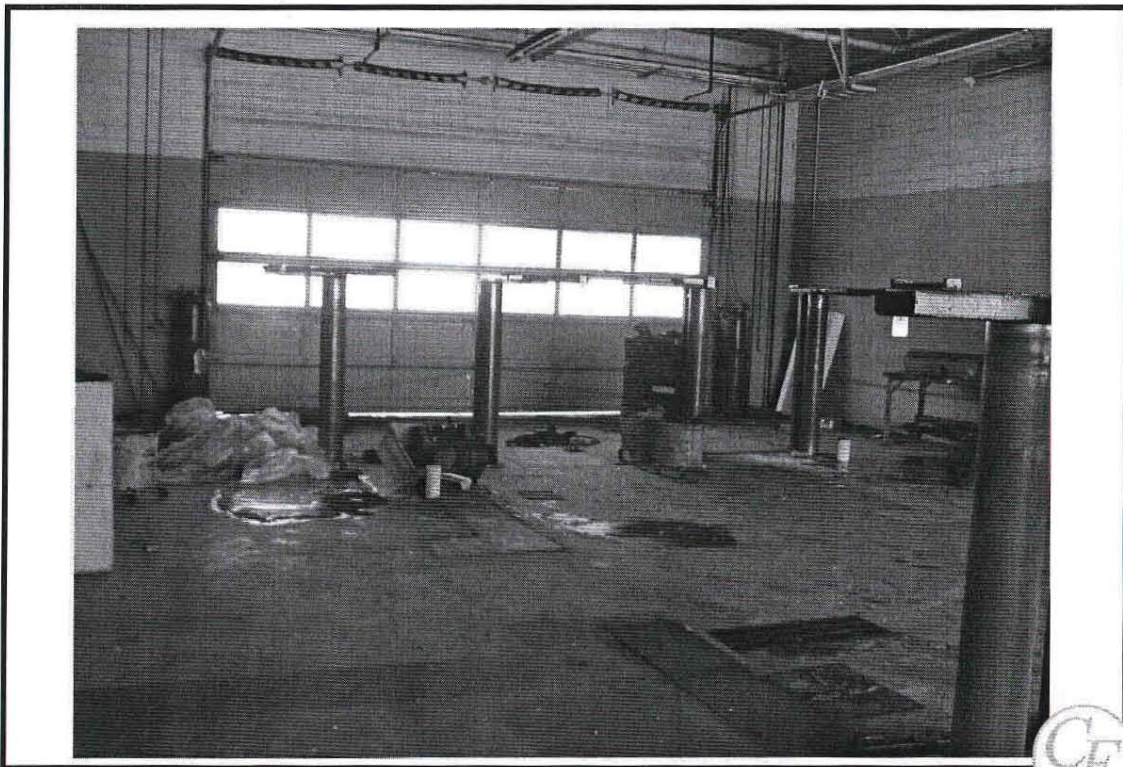
Hydraulic lifts - auto center.
7777 Edinger Avenue-Montgomery Wards, Huntington Beach, CA

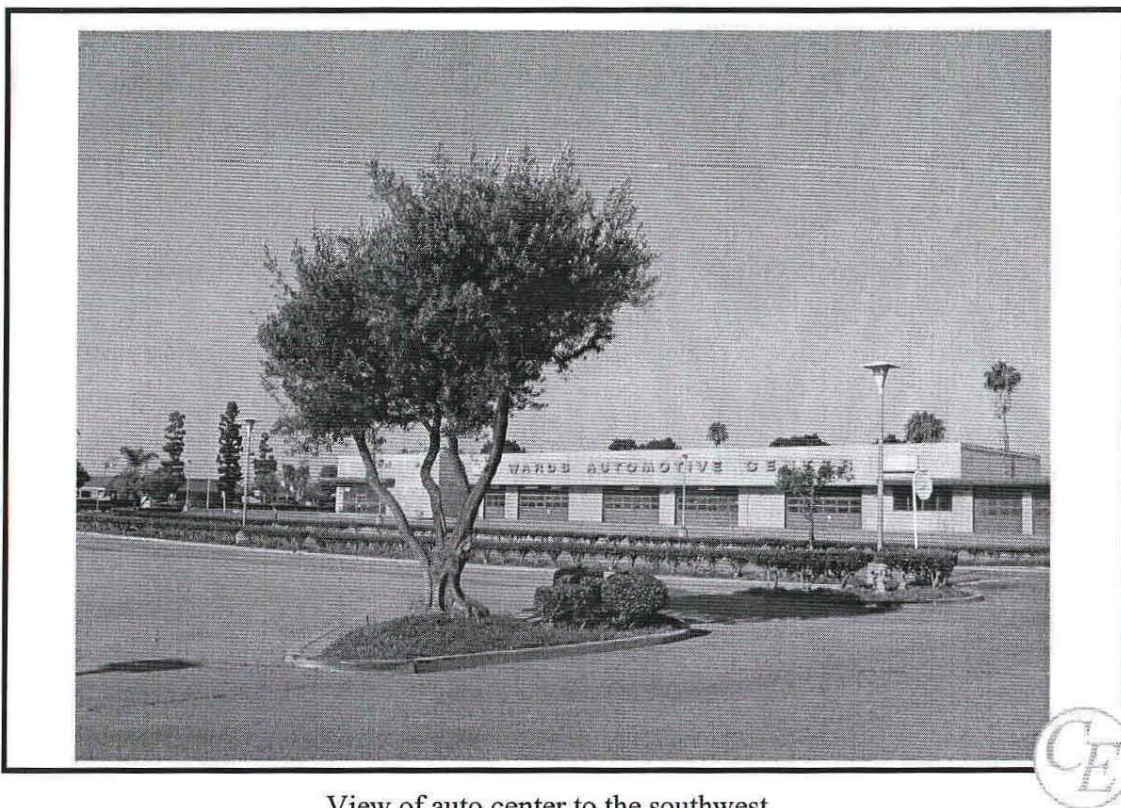
View of auto center to the southwest.
7777 Edinger Avenue-Montgomery Wards, Huntington Beach, CA

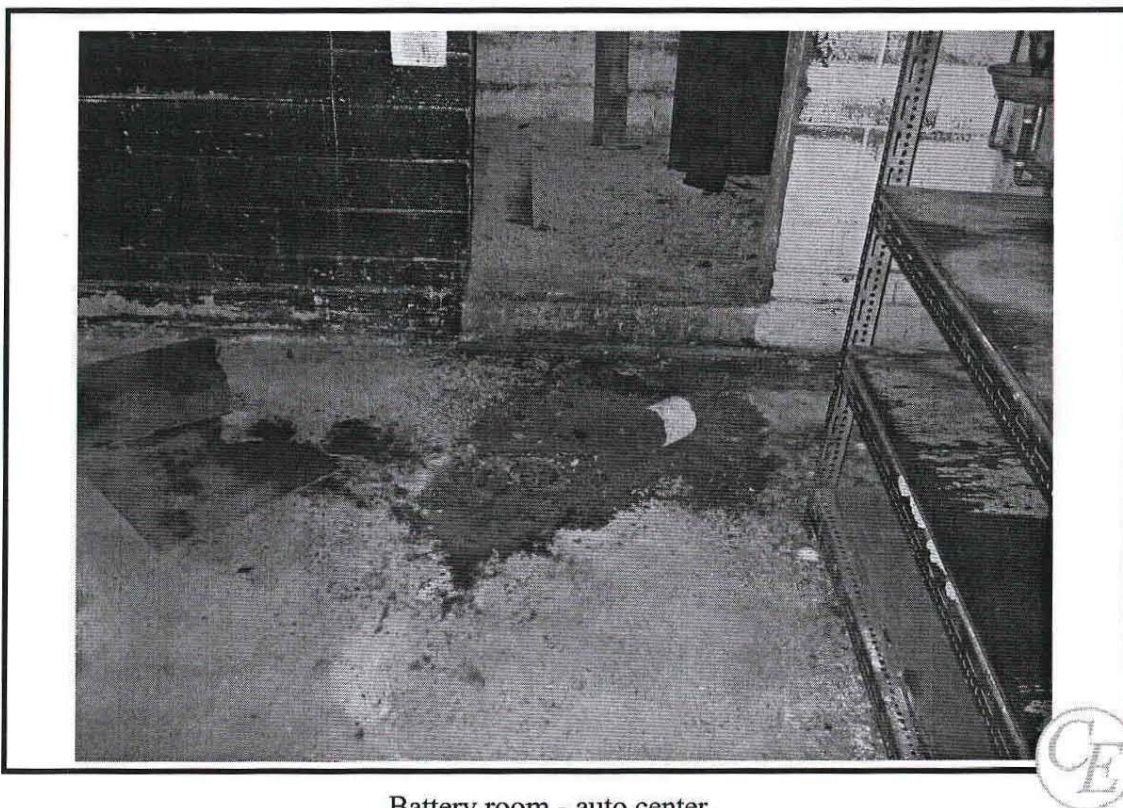
Automotive batteries were previously stored and serviced within the northern portion of the former Montgomery Ward Automotive Center structure. The concrete flooring located within the battery storage area is significantly degraded. The concrete flooring appeared to be etched from spillage of battery (sulfuric) acid. Areas of oil stained concrete were also observed within the automotive repair facility. No other evidence of staining or residue was observed on the subject property at the time of the site reconnaissance.

Battery room - auto center.
7777 Edinger Avenue-Montgomery Wards, Huntington Beach, CA

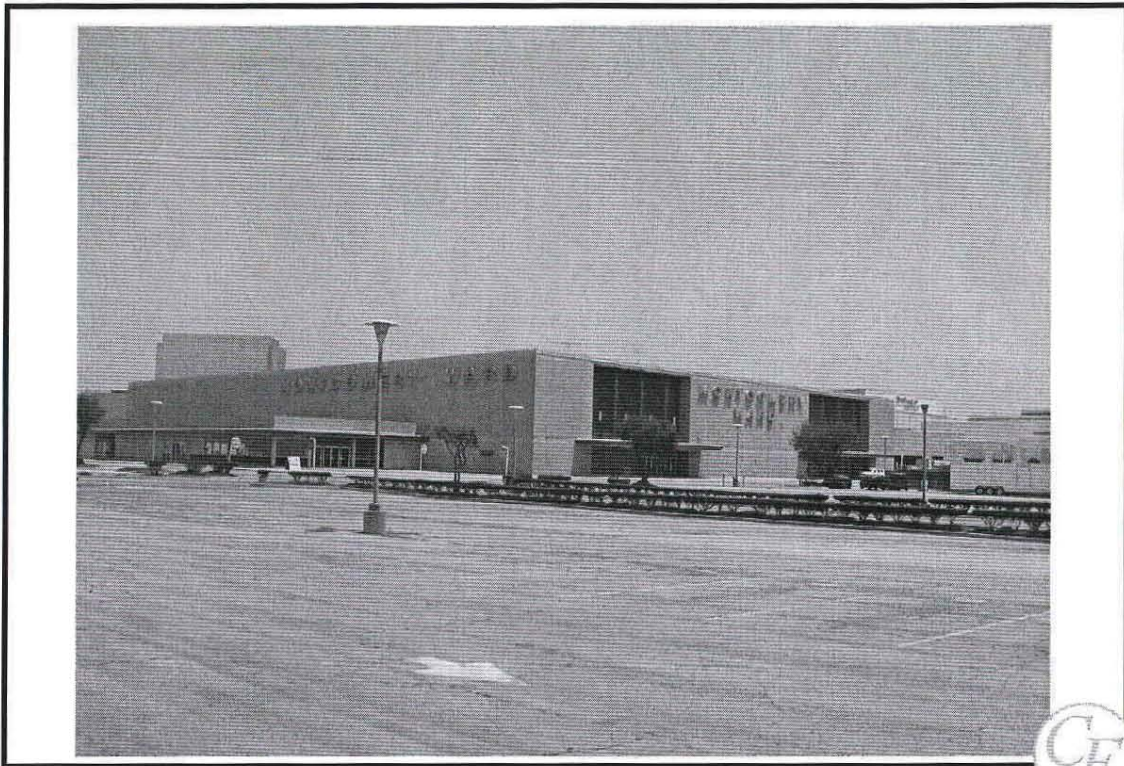
View of department store building.
7777 Edinger Avenue-Montgomery Wards, Huntington Beach, CA

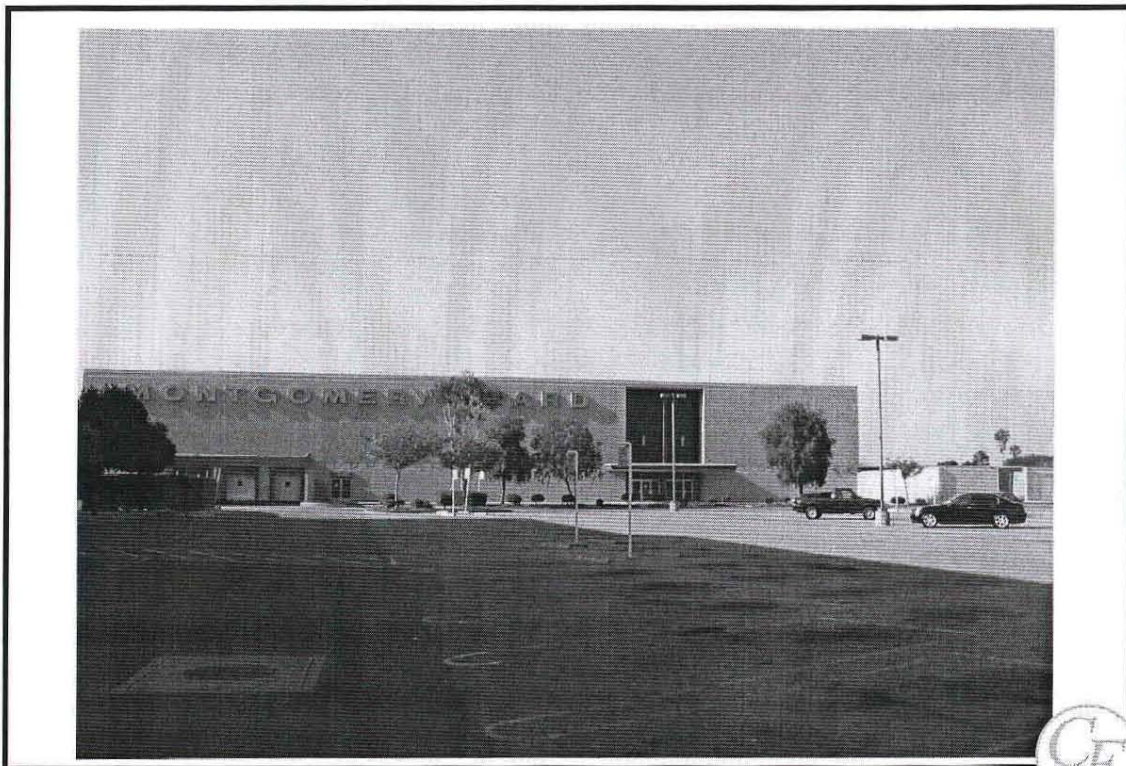
View of department store building to the west.
7777 Edinger Avenue-Montgomery Wards, Huntington Beach, CA

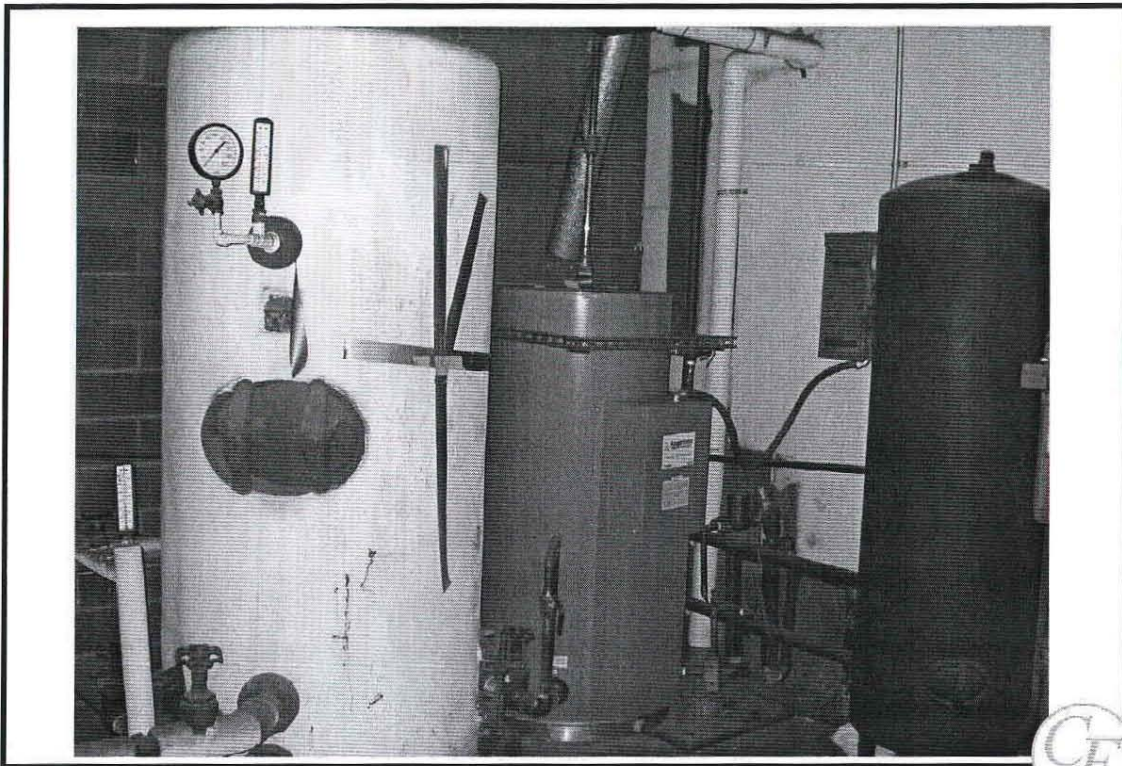
View of insulation, hot water system in department store.
7777 Edinger Avenue-Montgomery Wards, Huntington Beach, CA

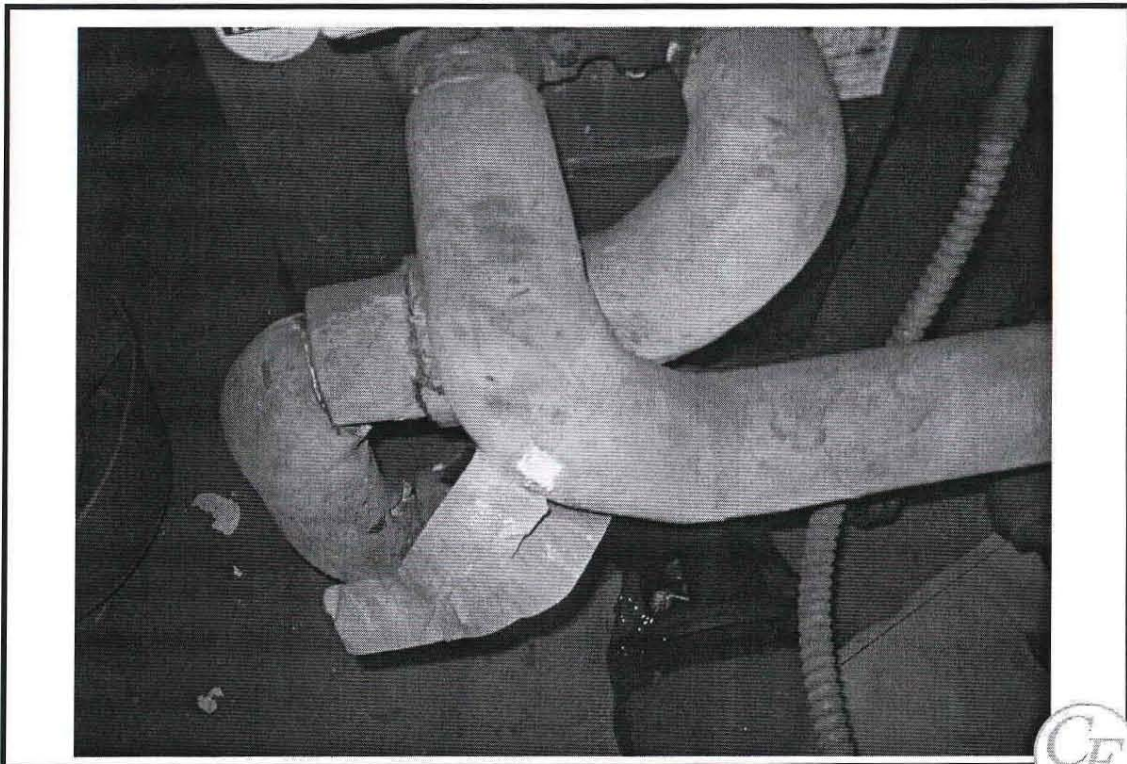
View of pipe insulation in department store.
7777 Edinger Avenue-Montgomery Wards, Huntington Beach, CA

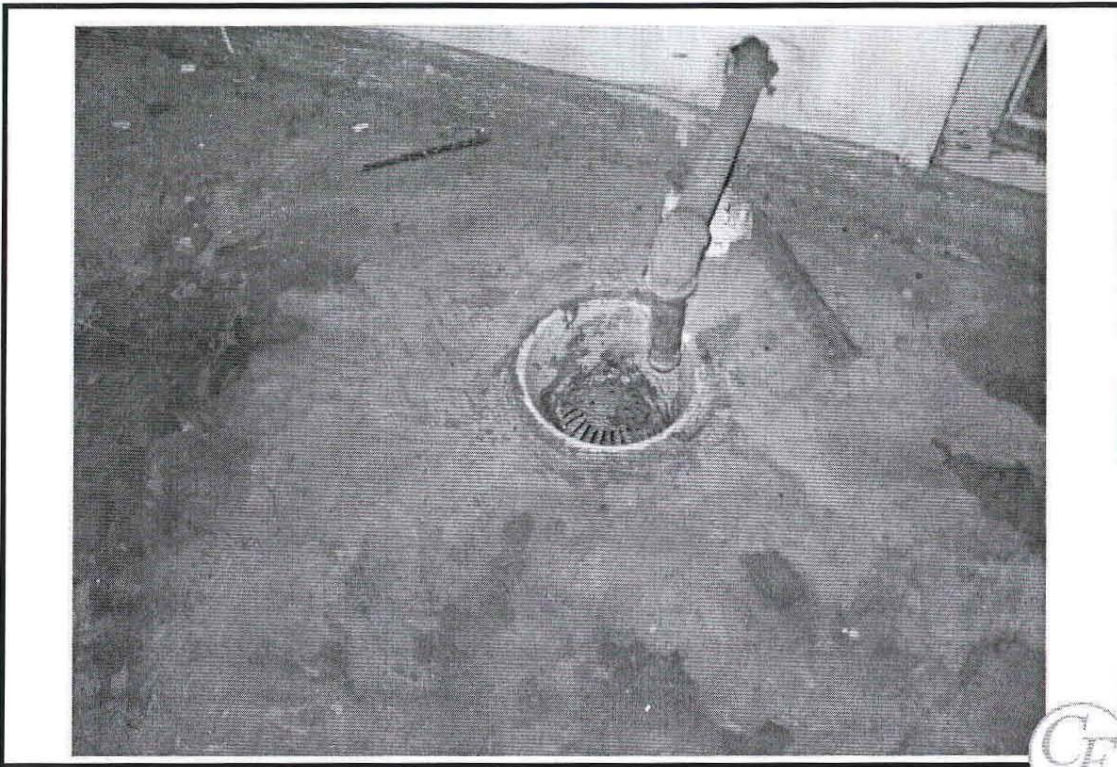
View of floor drain inside department store.
7777 Edinger Avenue-Montgomery Wards, Huntington Beach, CA

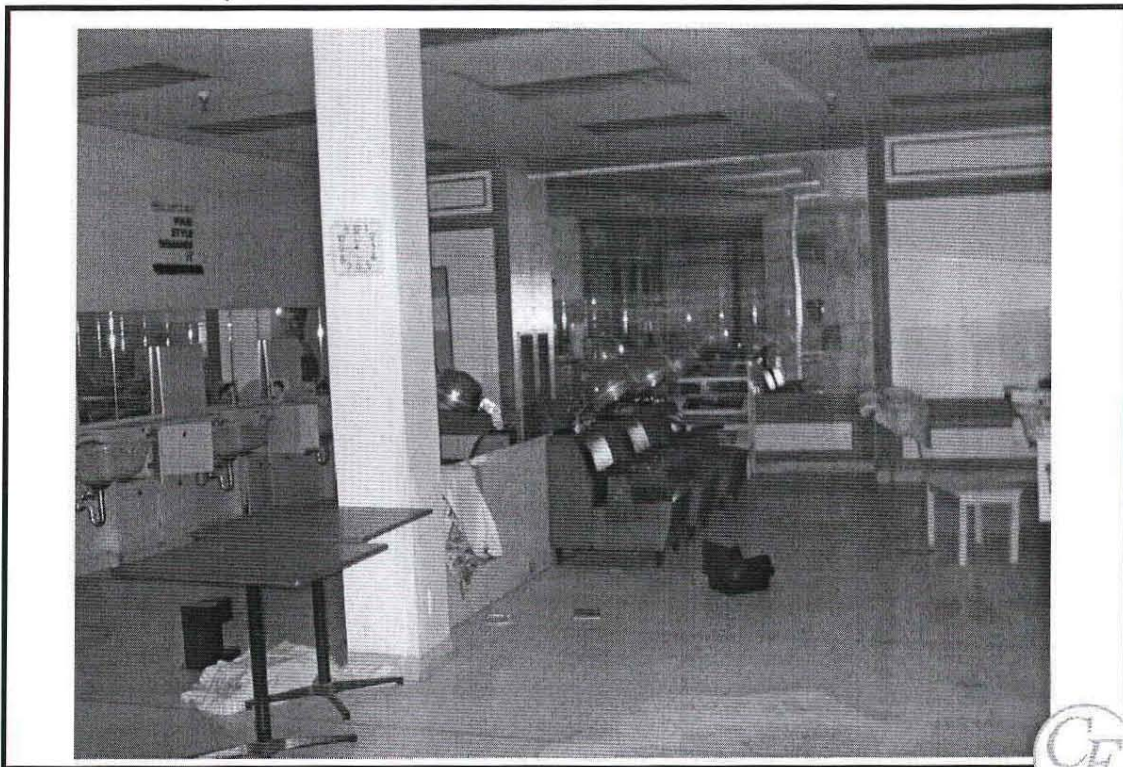
View of salon area inside department store.
7777 Edinger Avenue-Montgomery Wards, Huntington Beach, CA

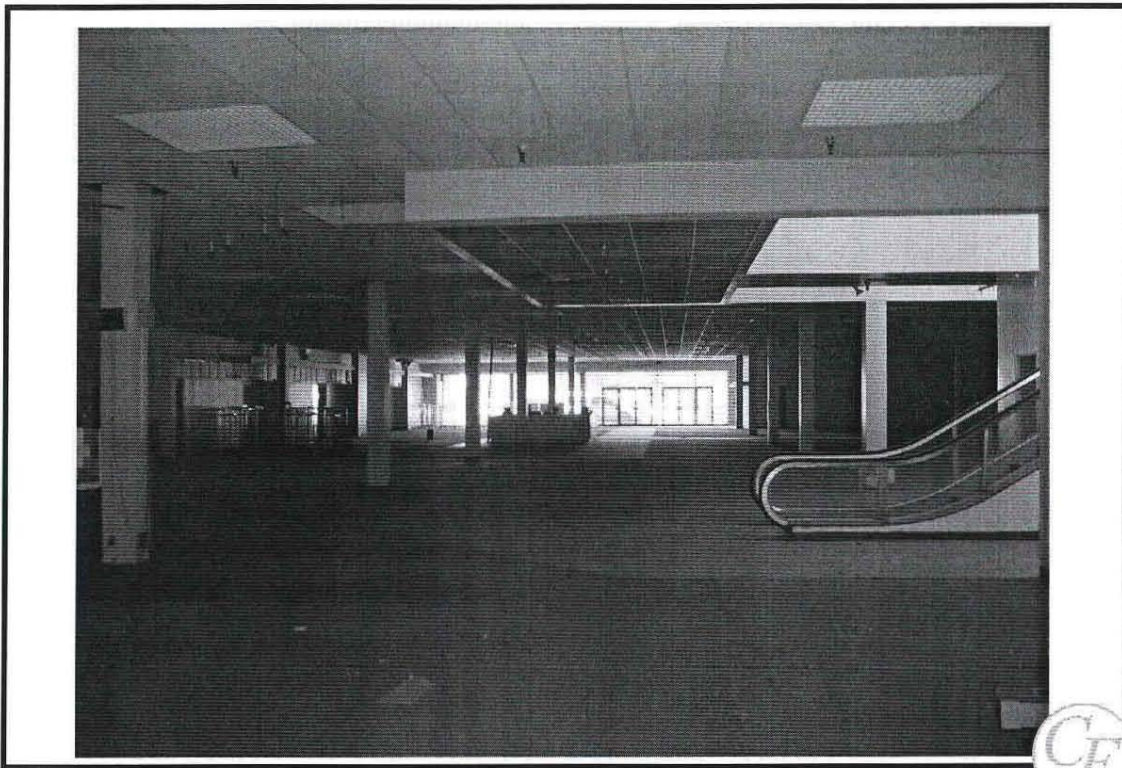
View of retail space inside department store.
7777 Edinger Avenue-Montgomery Wards, Huntington Beach, CA

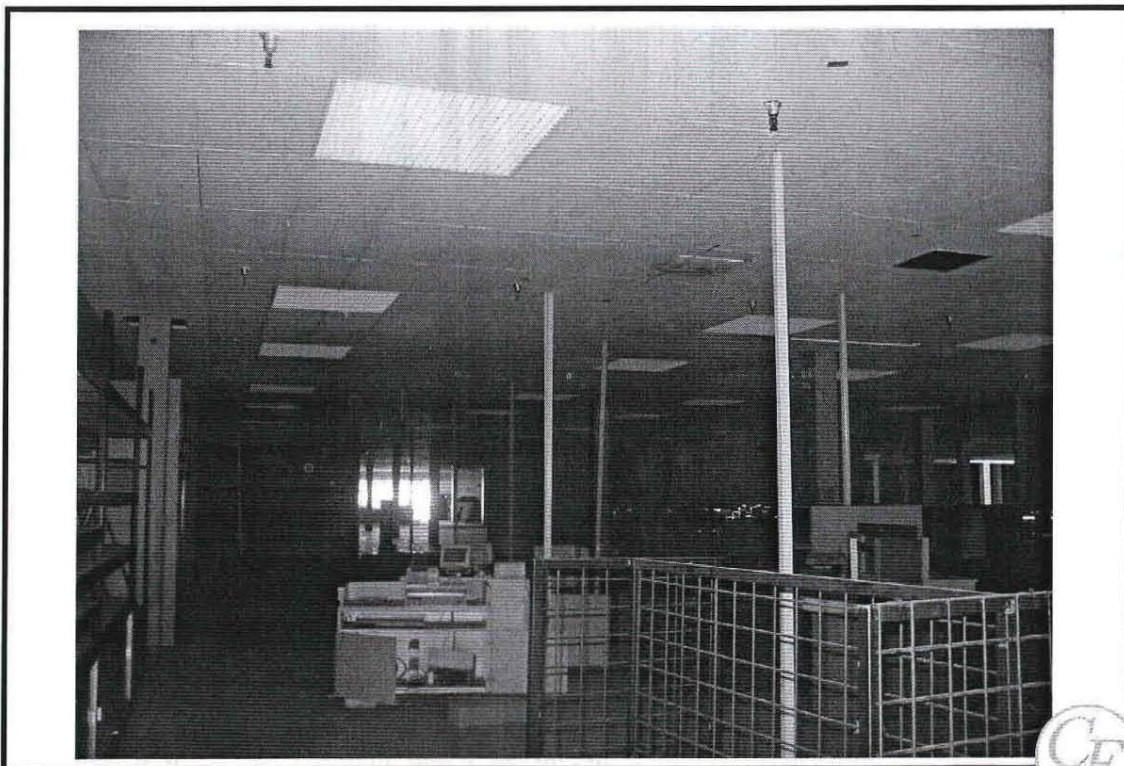
View of retail space inside department store.
7777 Edinger Avenue-Montgomery Wards, Huntington Beach, CA

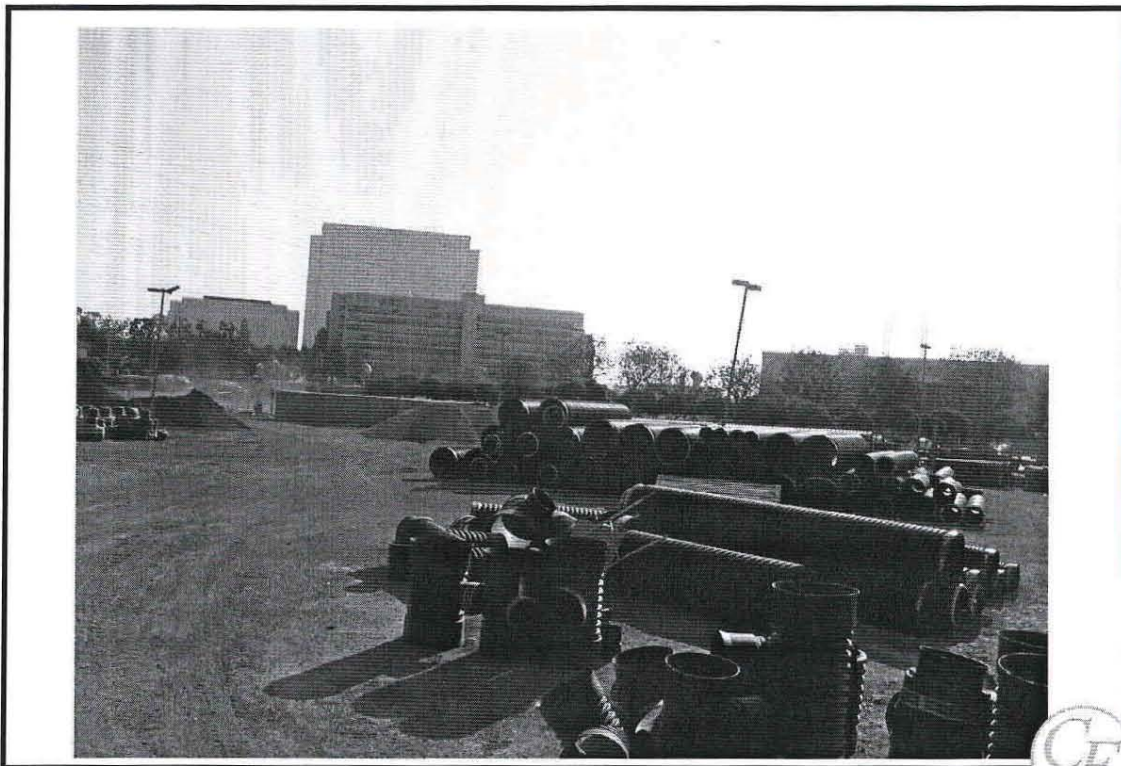
View of material storage area on the northwest portion of property.
7777 Edinger Avenue-Montgomery Wards, Huntington Beach, CA

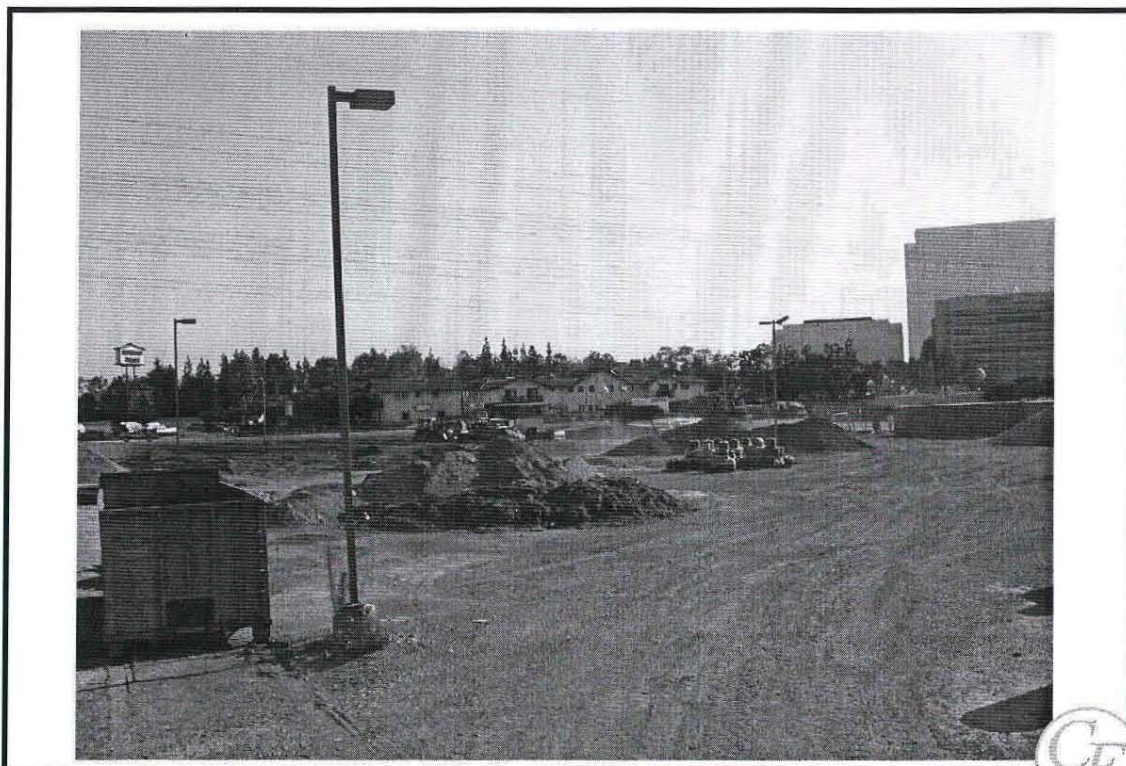
View of material storage area on the northwest portion of property.
7777 Edinger Avenue-Montgomery Wards, Huntington Beach, CA
